Biofilm

Silicone Sealing Rings

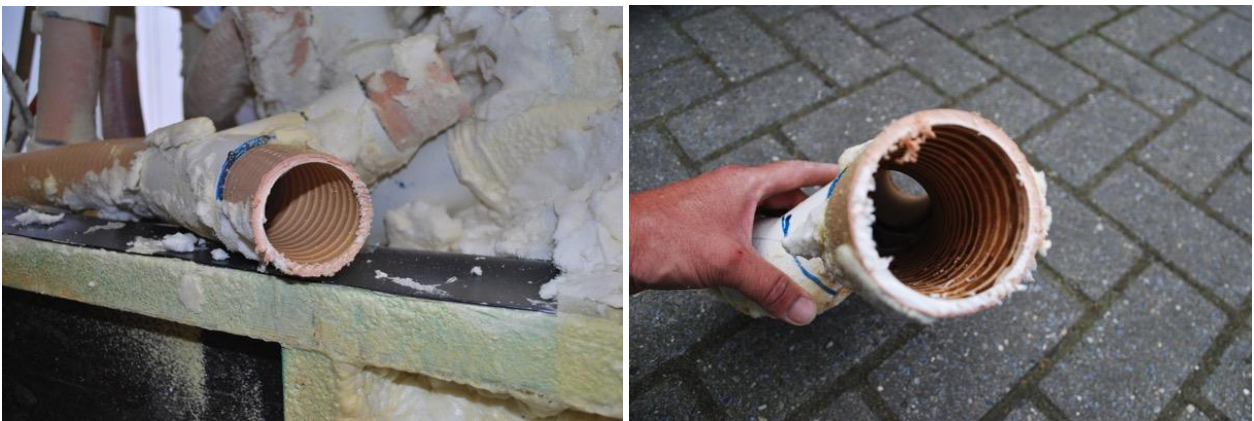
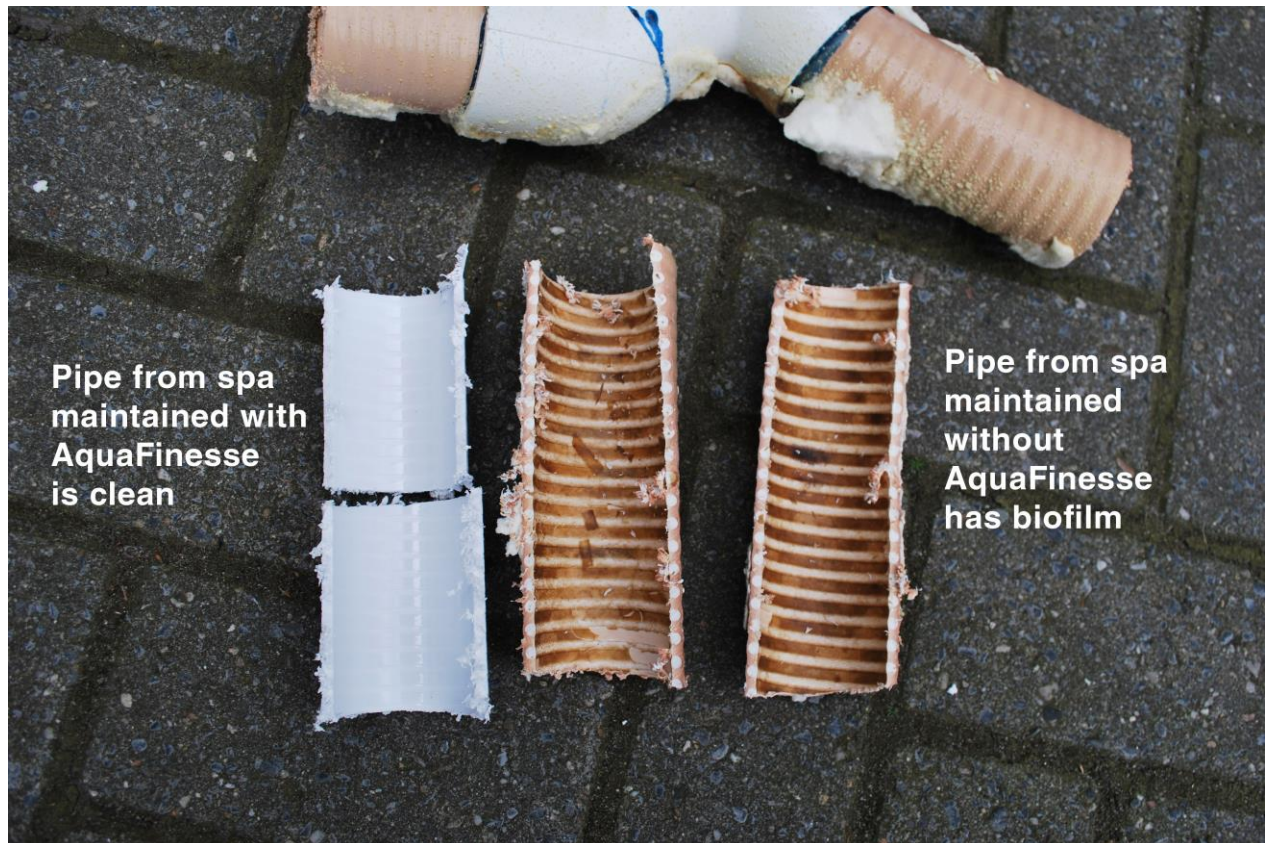
Biofilm is the biggest enemy of the spa. Standard water treatment products all fight against the notorious biofilm that consists of bacterial colonies. Below you can see a spa that has been exclusively treated with normal chlorine. There were leakages on several places.

After cutting the pipes of the spa, an enormous amount of biofilm appeared. The most traditional way to solve this problem would be to flush out the pipes with high levels of chemicals for days and damage the spa even more.

The spa owner had to have used a lot of chlorine to keep the water clean, since the biofilm in the pipework was so gigantic. Costs to repair can be substantial.

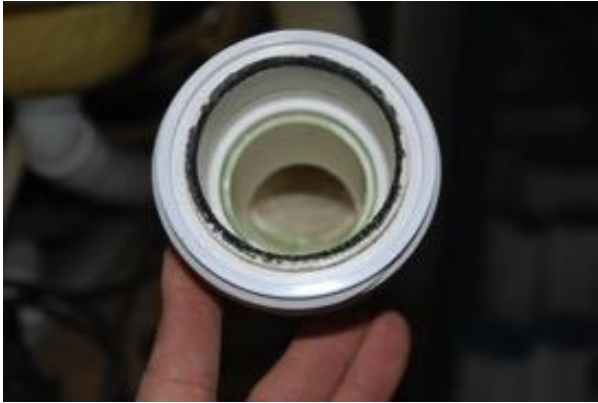
O-rings are between all joints and connections of pumps and heaters. The first pictures show two sealing rings from a spa maintained with AquaFinesse for 10 years. After 10 years, the O-rings are still reasonably transparent. With the use of chlorine, they mostly become yellow and weak, eventually dissolving and resulting in leaks. The black rubber rings will eventually dissolve completely as they are made from rubber.

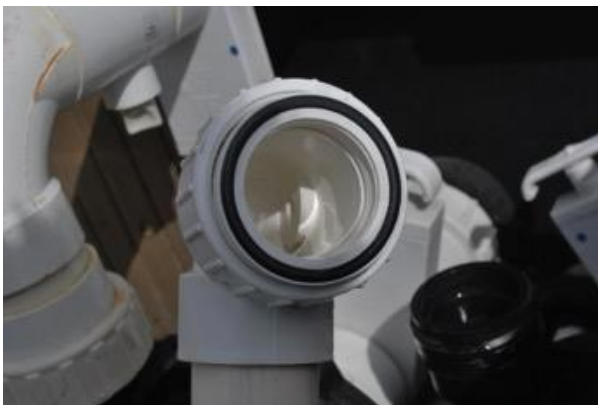
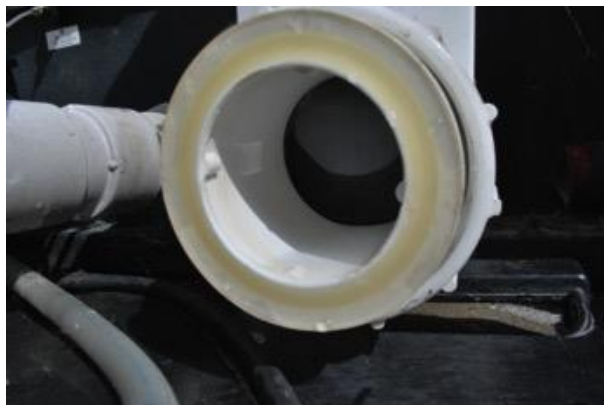
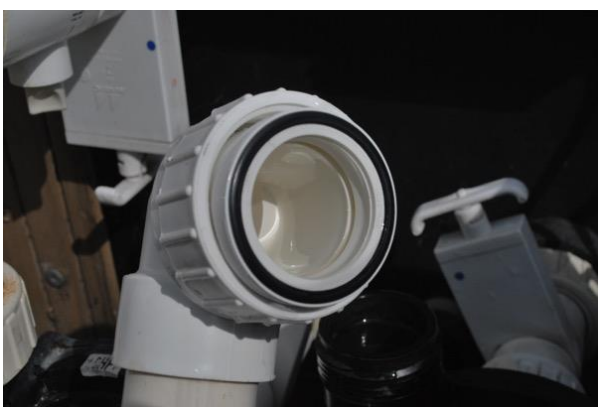
The O-rings are still totally clean after use of AquaFinesse. There is no sign of damage. The sealing rings below have been used since 2004.

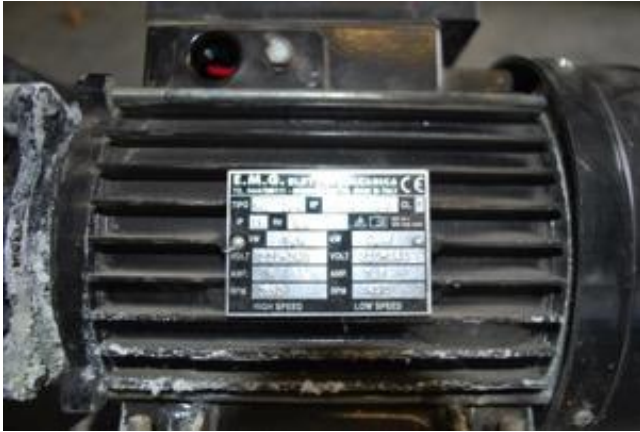
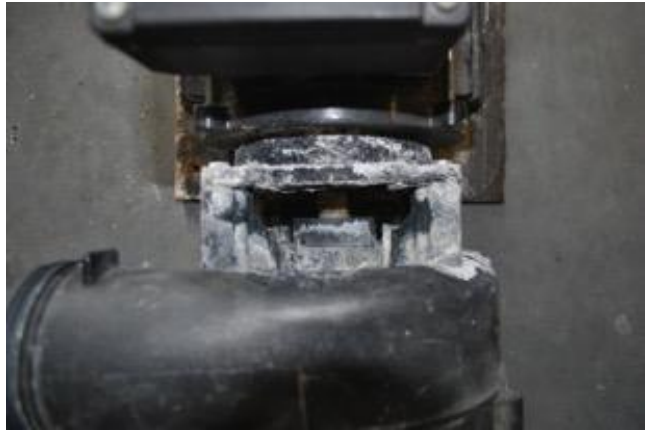
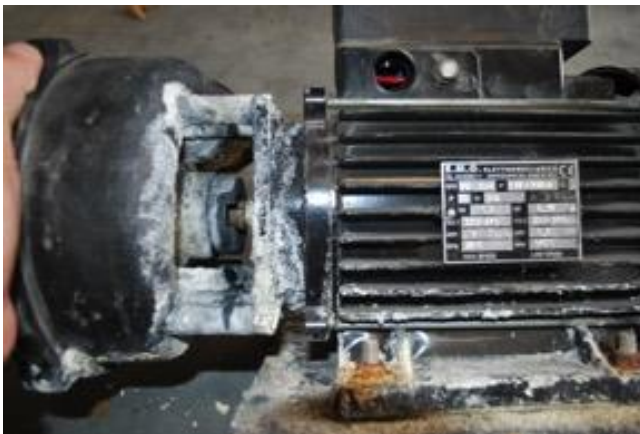
Harsh chemical products such as chlorine can damage equipment. The water behind the drive shaft is held back by an O-ring which is affected by the high level of chlorine and will eventually break and start leaking. It begins with moisture, then drops and in the end the water reaches the electrical coil of the pump which will cause the pump to break down.

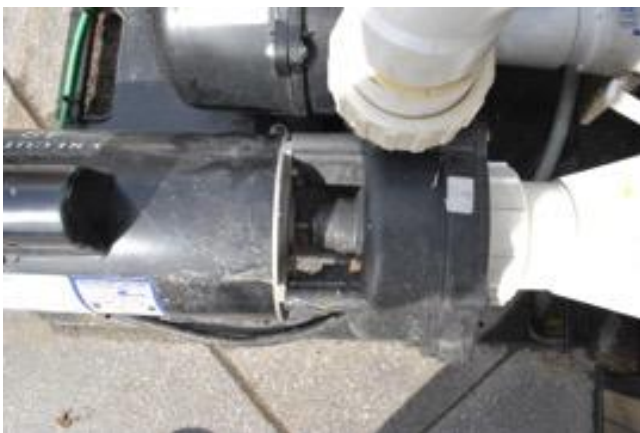
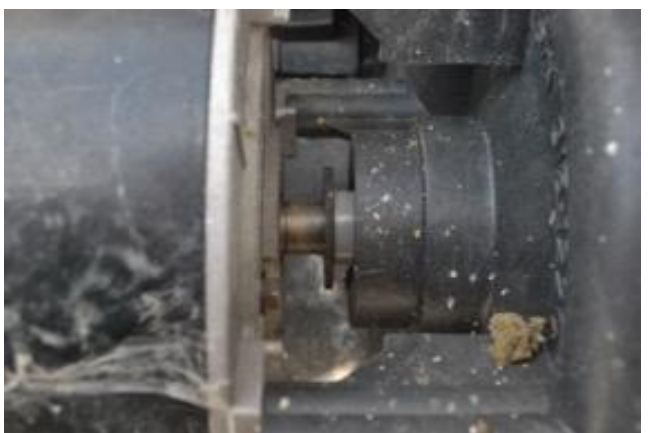
Spa maintained with AquaFinesse for 10 years:

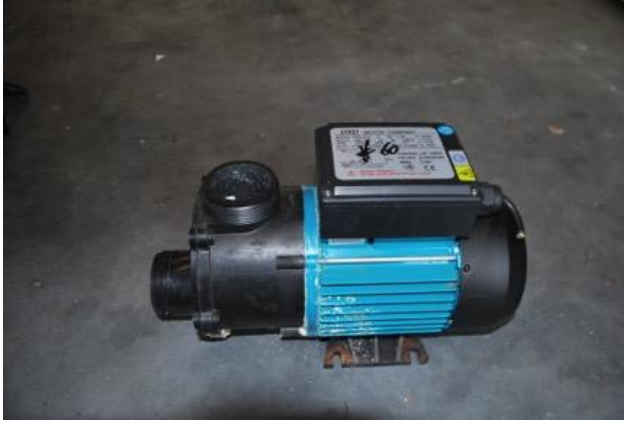
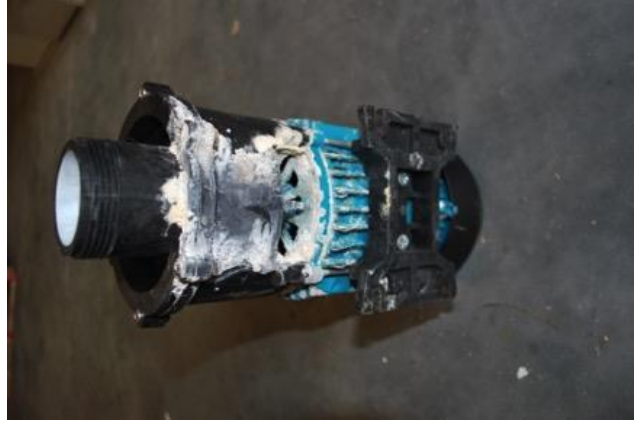
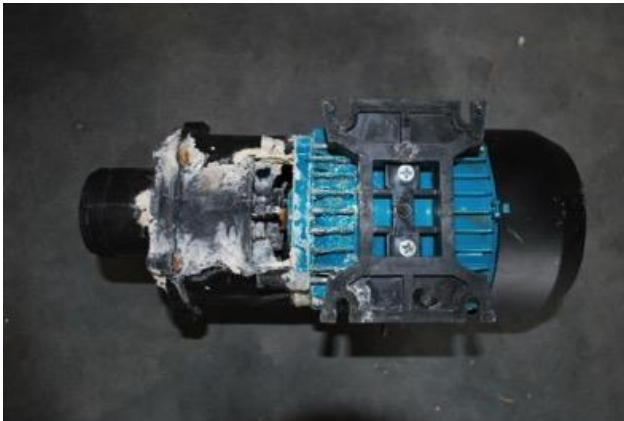
Circulation pumps usually run 24 hours a day. These pumps are rather small and quiet pumps. As you can see on the picture, this is a clear case of an O-ring corroded under the influence of chlorine and bad PH levels.

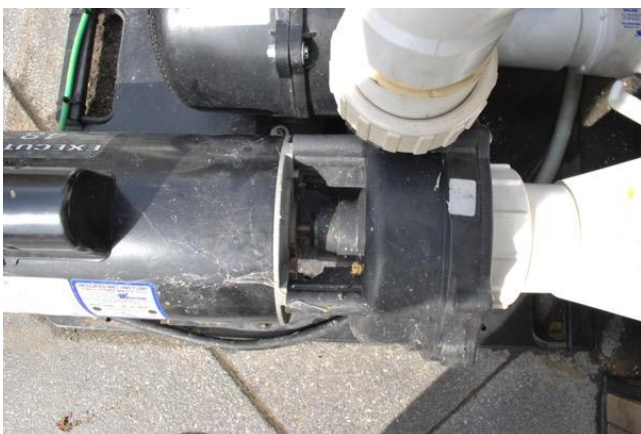
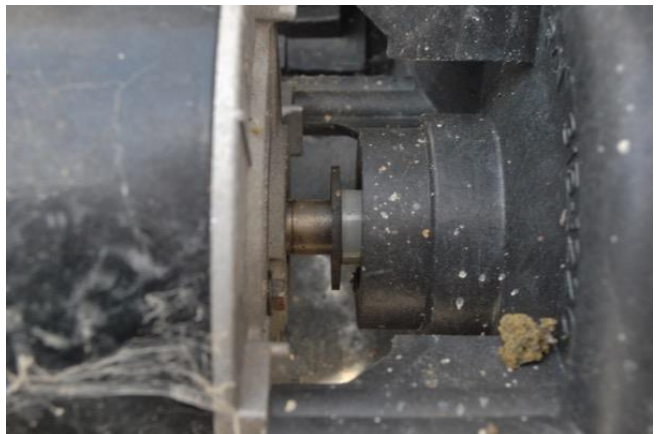
Pump from spa maintained with AquaFinesse for 10 years:

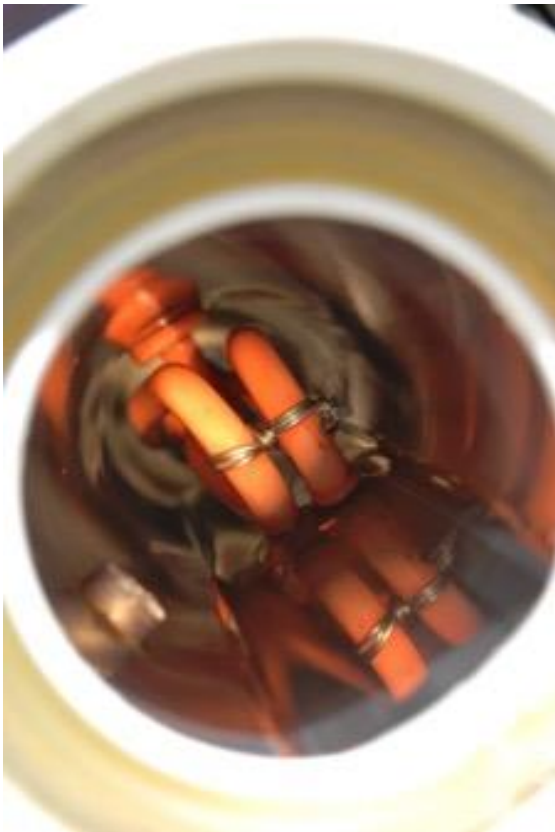
Heater from spa maintained with AquaFinesse for 10 years:

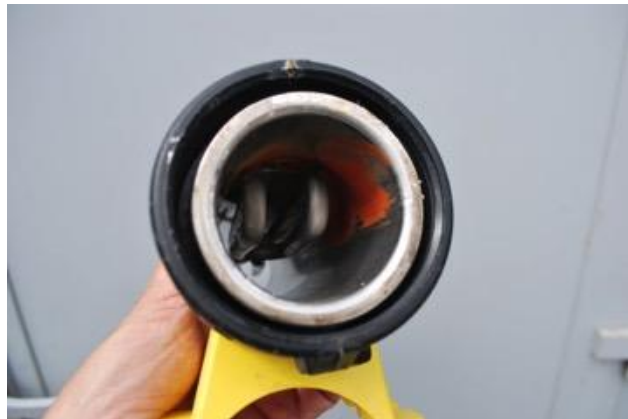
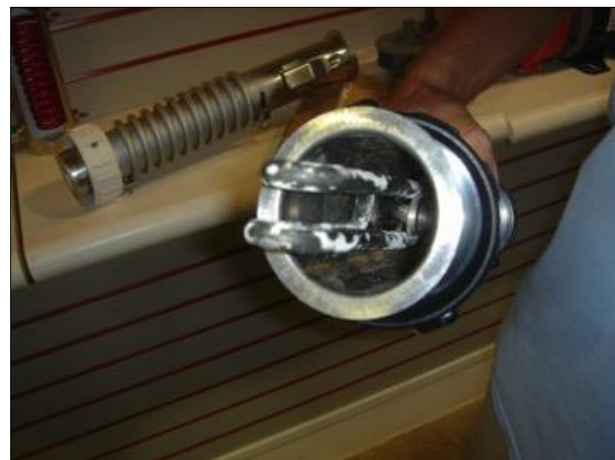
Heaters will generally break down because of bad pH levels. This causes rust and eventually damages the welded joints, the weakest part of the heater. As a result, there will be a short circuit and the heater will be broken.

Broken heaters:

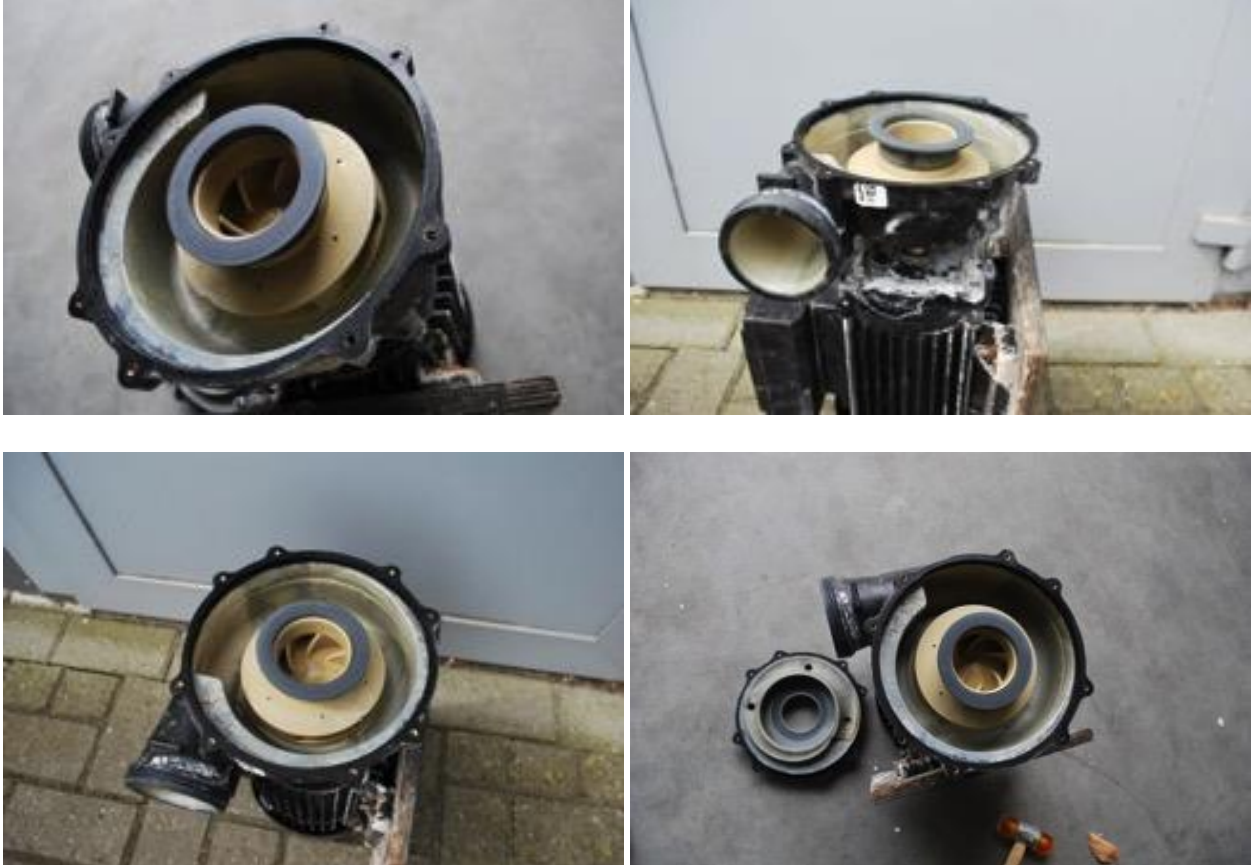
The pump wet end is the part of the spa that has to do the work. It is an impeller that is attached to the pump motor. Its function is to push the water through the spa pipes and through the spa jets. When there is calcium buildup on the wet end, the surface becomes rough. This is the ideal spot for bacteria to settle.

Effects on spa maintained with standard chlorine:

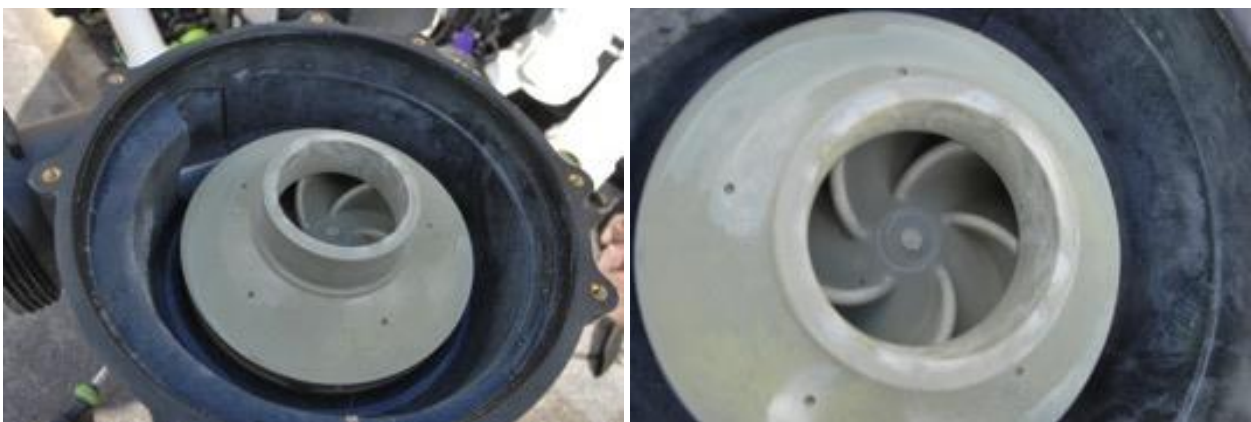
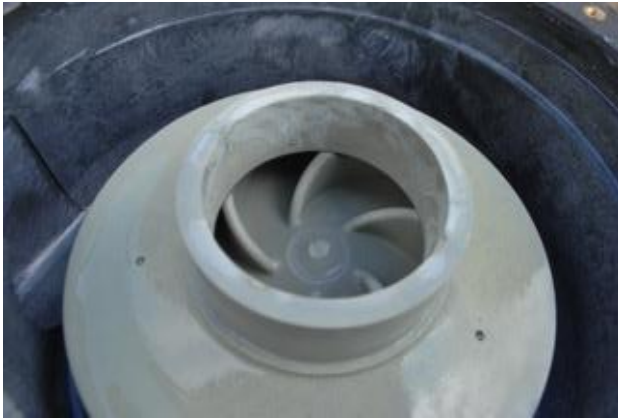
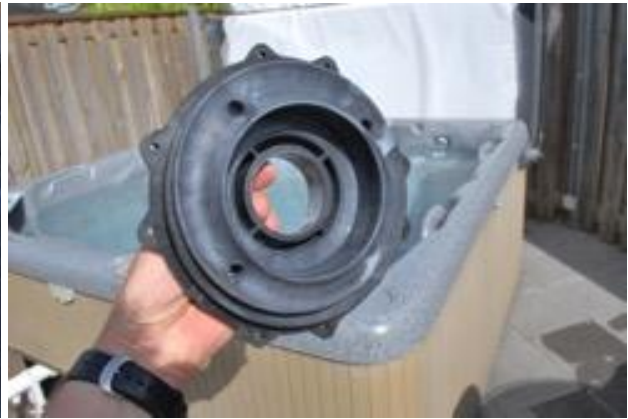
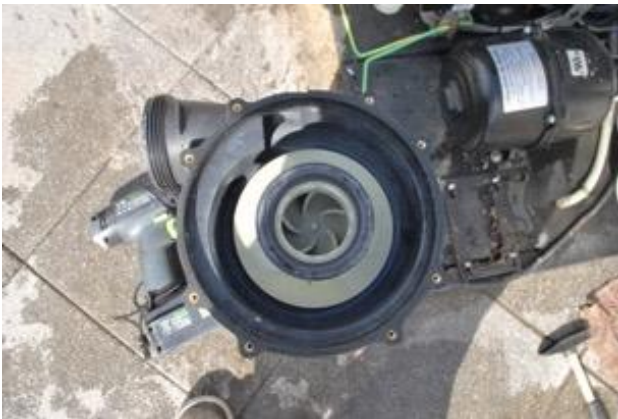
No damaging effects on spa maintained with AquaFinesse since 2004:

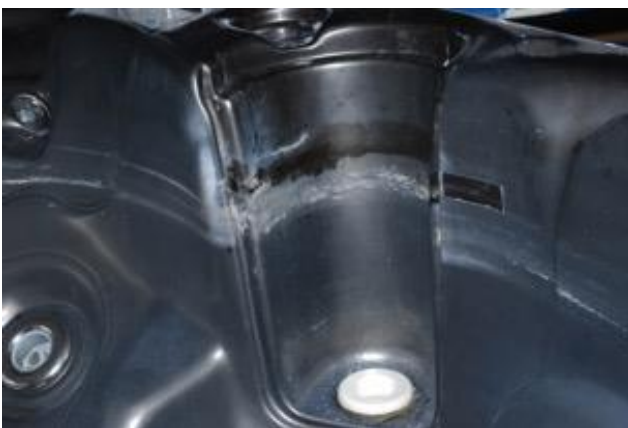
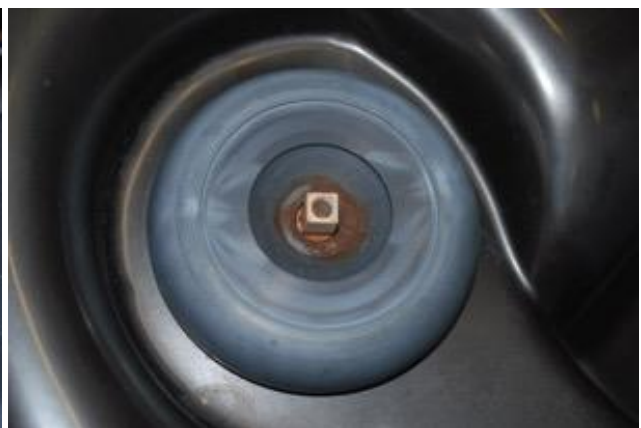
It is not surprising that bad water treatment affects all kinds of spa parts. The bath itself, the cover, display, control panel, buttons and so on. This damage is irreparable.

Here are some pictures that indicate the effects of chlorine treatment.

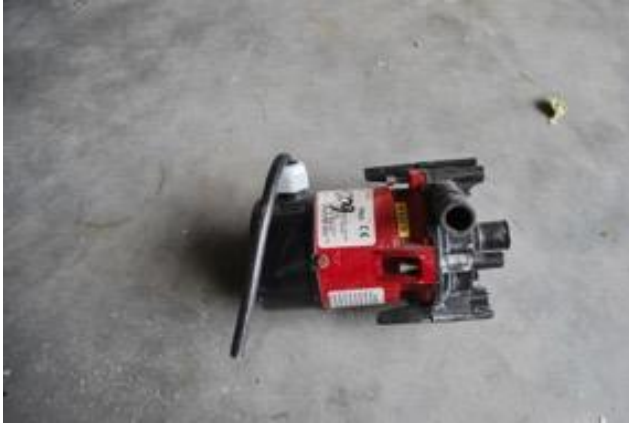
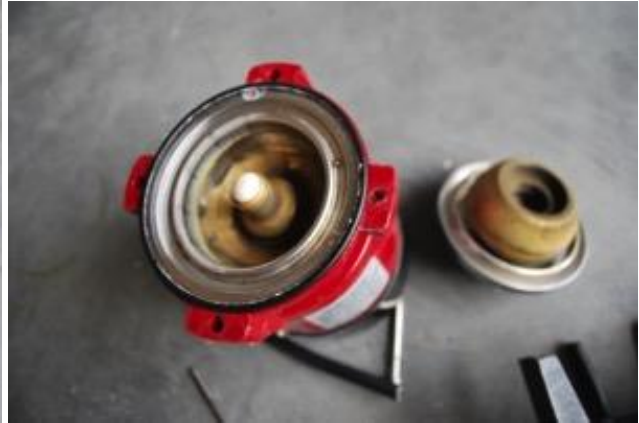
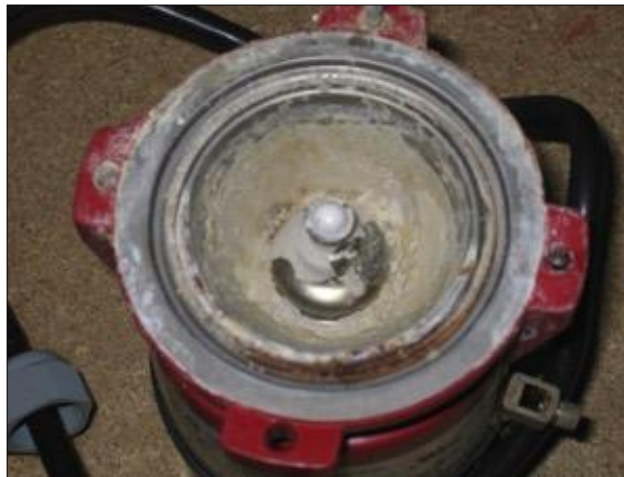
Sometimes diaphragm pumps, also known as membrane pumps, are used as circulation pumps. Just like other pumps, these small ones also perish due to calcium and biofilm.

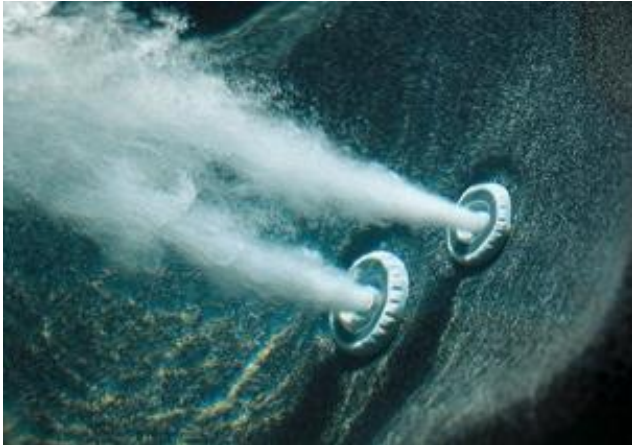
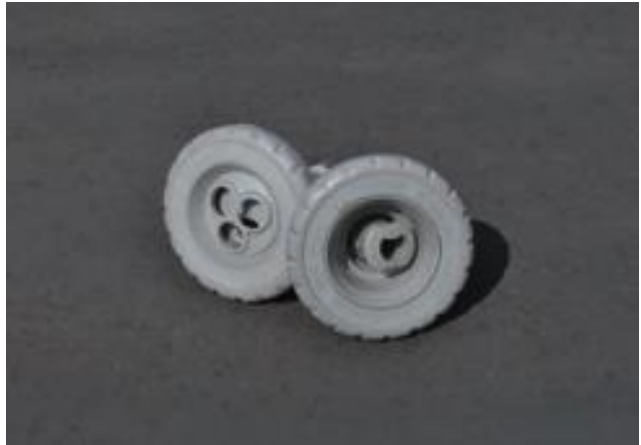
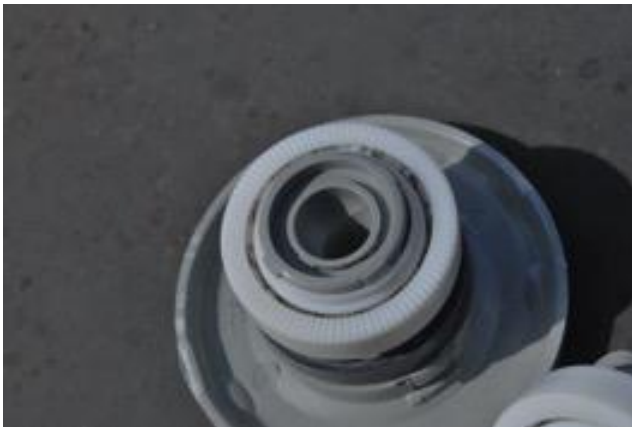
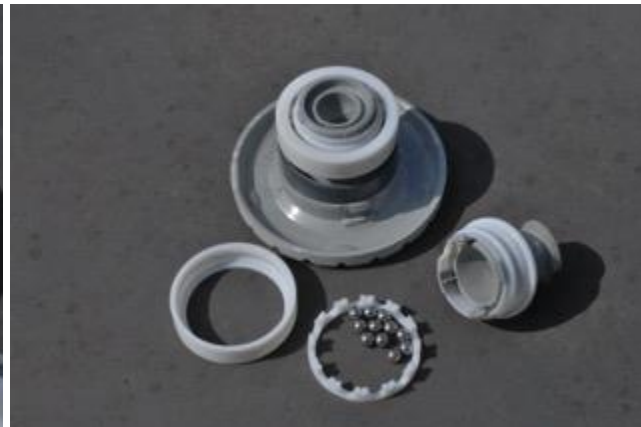
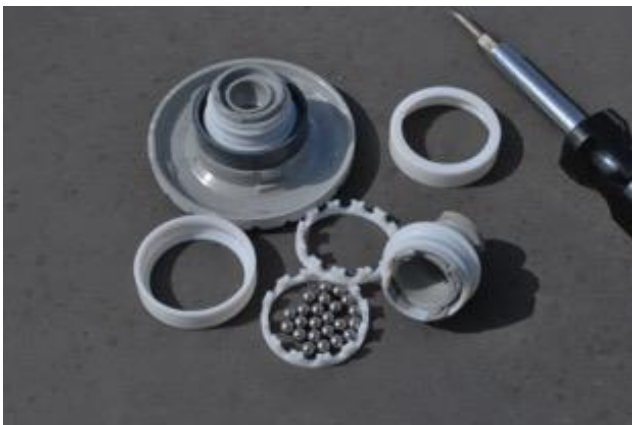
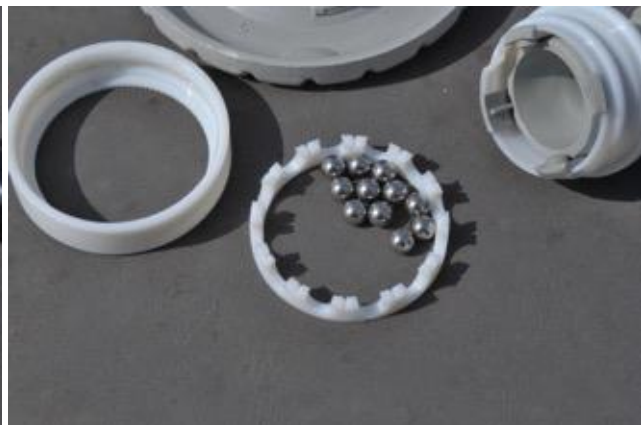
The massage jets rotate very fast and smooth. But over time, a thin layer of calcium forms on the ball bearings. In the worst case the jets stop rotating completely.

The jets on a spa maintained with AquaFinesse for 10 years are still clean and run correctly. Even the discoloration is minimal, which is expected after 10 years.
